HARDWARE ERRATA REPORT

P/N PBA-B-01

phyFLEX Baseboard

Revision A1, 14 February 2014

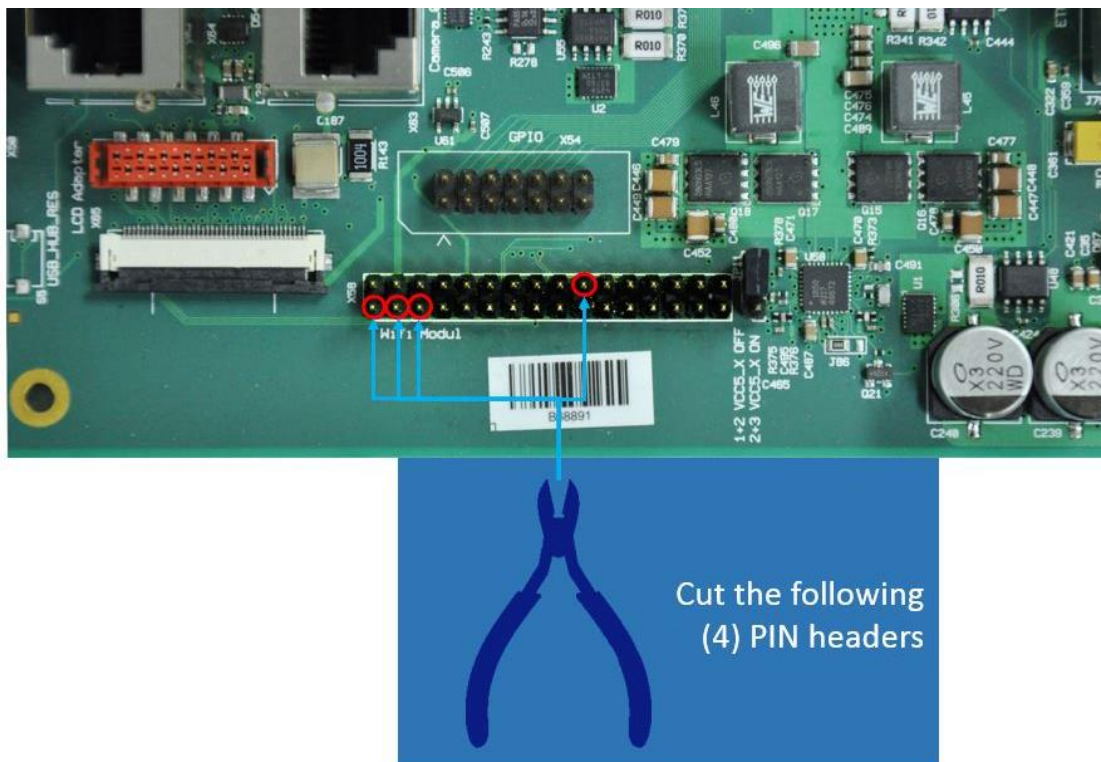
Figure 1: Errata 01 Rework

Errata Impact: The i.MX6 fails to boot from SPI NOR Flash when the WiFi module (PCM-958) is connected.

Errata Description: The Baseboard routes SPI0 signals to the WiFi module connector X58. When the WiFi module (PCM-958) is connected to the Baseboard the SPI0 signal voltage lowers. Since the SPI0 signals are connected to the i.MX6 SOM on-board SPI Flash the board will fail to boot from SPI Flash.

Workaround: Hardware rework is required to disconnect the SPI0 signals from being routed to the WiFi module. On the Baseboard cut the SPI pin headers 1, 3, 5, and 20 at X58. Figure 1 below shows which pins must be cut before inserting the WiFi module.

Errata Fix: Planned for Q2 2014

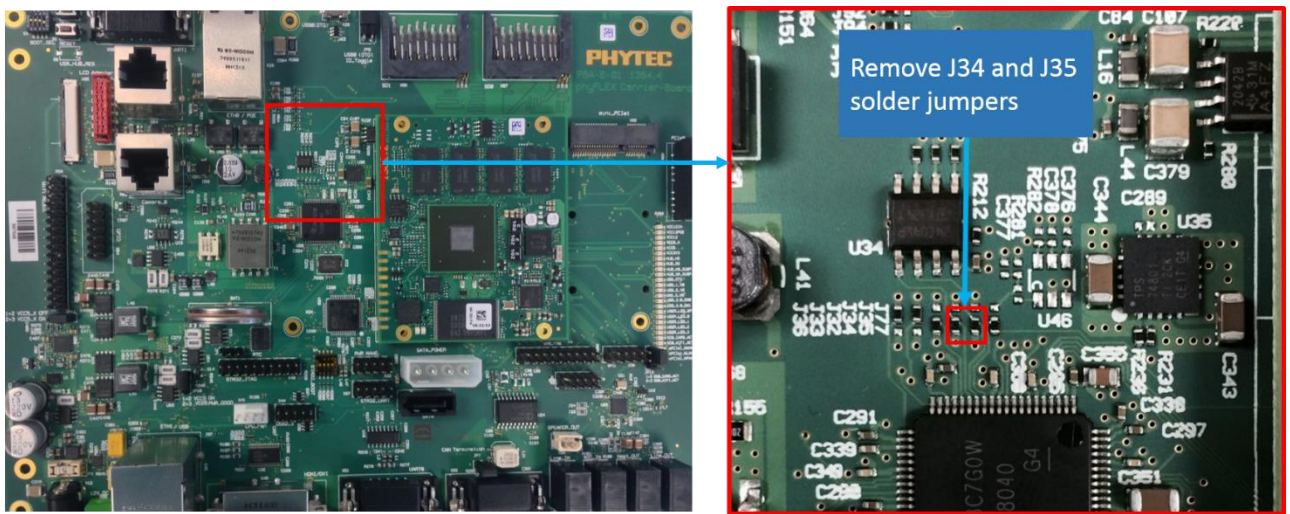
Figure 2: Errata 02 Rework

Errata Impact: USB devices plugged into X45 fail to be recognized by the i.MX6.

Errata Description: The pull-up resistors connected to the serial clock terminal (SCL_SMBCLK) and serial data terminal (SDA_SMBDAT) on the TUSB8040 USB Hub indicate that an I2C EEPROM is connected. However, because the EEPROM on the baseboard is empty the TUSB8040 will go into and stay in programming mode. This results in the TUSB8040 reporting as a programming end point to the USB Host controller and not being able to recognize the connection of USB devices.

Workaround: Set the TUSB8040 to indicate that an EEPROM is not connected by removing the pull-up resistors on the SCL_SMBCLK and SDA_SMBDAT signals. To do so, perform hardware rework to remove J34 and J35 solder jumpers on the baseboard. Figure 2 below shows which resistors must be removed.

Errata Fix: 1364.5
